# DOE/NASA TECHNICAL MEMORANDUM

DOE/NASA TM-78179

## FINAL REPORT ON MSFC ASSESSMENT OF OWENS-ILLINOIS SUNPACK<sup>TM</sup> COLLECTOR PROBLEMS

National Aeronautics and Space Administration  
George C. Marshall Space Flight Center, Alabama

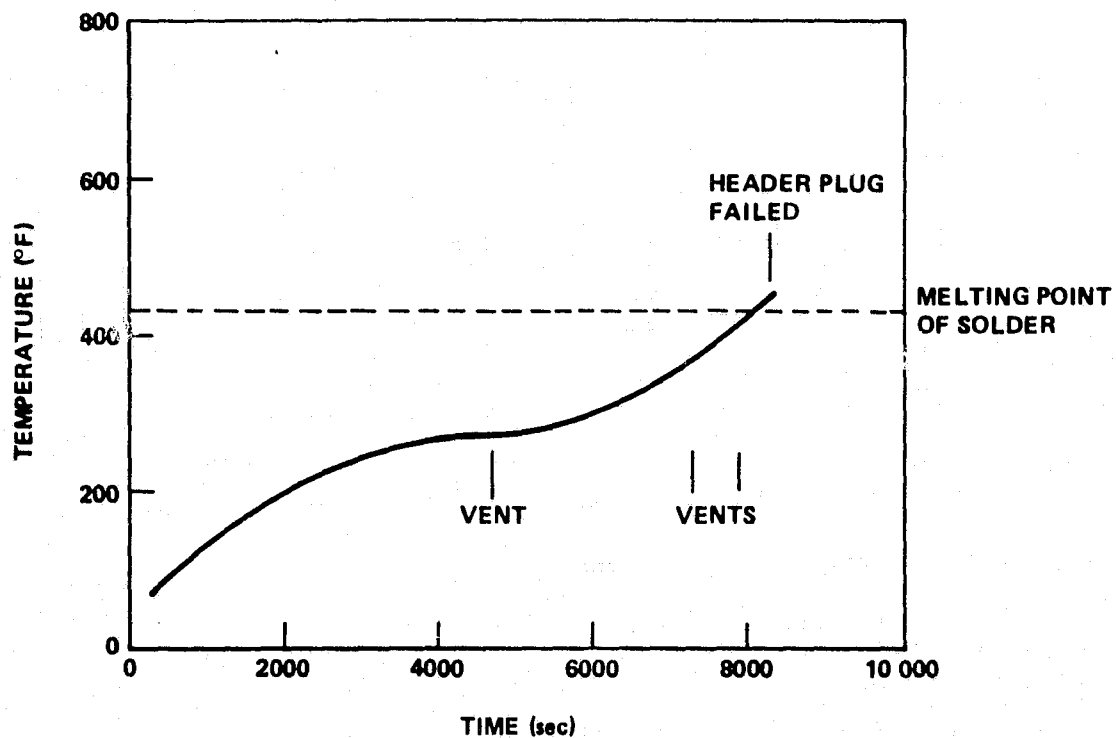
Figure 13. Temperature history of cup 12 for header plug failure.

The conditions which resulted in failure of the manifold solder can be understood from the temperature data shown in Figure 13 for tube cup 12 which is near the soldered manifold header plug that leaked in a second day boilout test. As venting begins, the temperature of steam passing through empty tubes at stagnation temperature begins a rapid rise. This temperature rise of steam is then similarly transferred to the copper manifold elements which interconnect the tubes. The time at which the melting point of solder is reached and failure occurred is shown. Figure 14 compares temperature of cup 8 to temperatures of the tubes upstream and downstream of the cup. The tube temperatures are those sensed by thermocouples located nearest the manifold.

The process of joining the copper manifold elements with solder is not adequate; analysis and test show some joint areas are too small for carrying loads and the melting point of solder is too low for the temperatures of stagnation and boilout. Alternate solutions include a precision cast manifold with no soldered joints or a new design which would permit brazing the elements together. No significant degradation of the foam core of the manifold resulted during solar simulator tests; however, proper formulation and mixing of the foam are critical to ensure that the foam will not degrade. Higher temperature foams are identified should foaming with the current material become a problem. O-I will change the insulation cover to a fiberglass reinforced polyester composite material since the current gelcoat cover material tends to deform with heat.

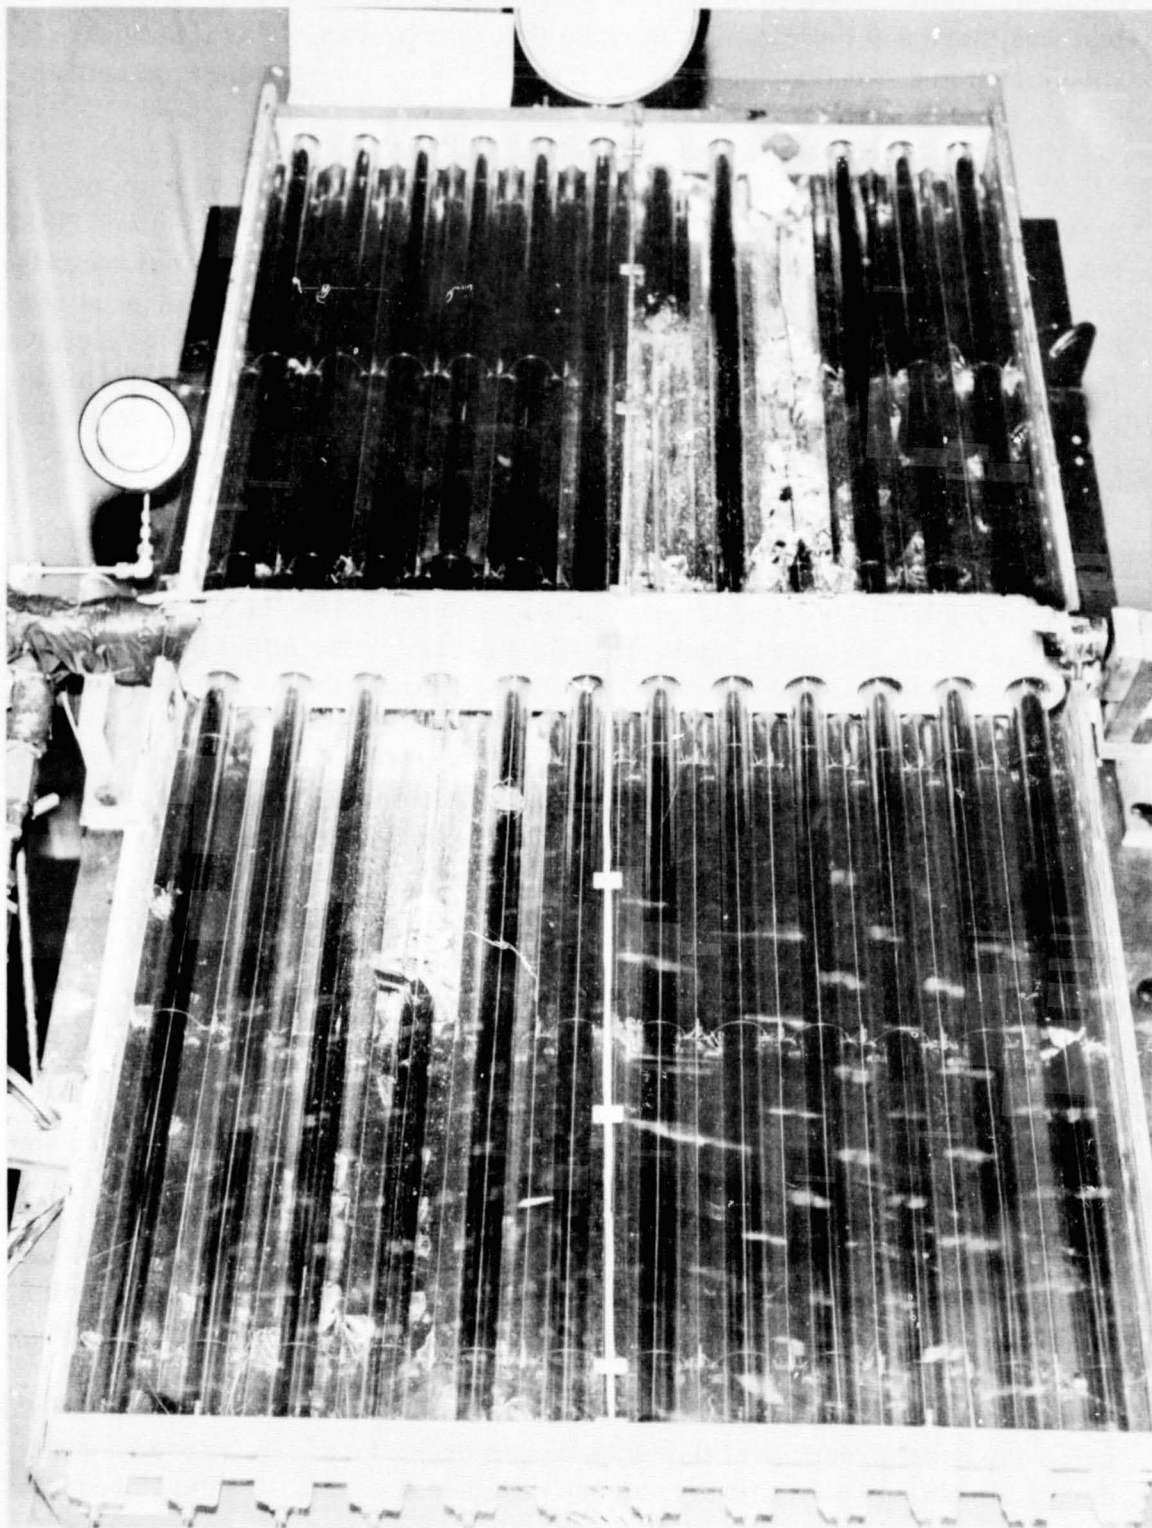
Figure 15. First failure with scratched tubes.

Figures 15, 16, and 17 show the failed condition of the first set of scratched tubes after the collector had cooled to permit safe inspection. Violent fracture had occurred in tubes 16, 7, and 9; tubes 17 and 24 suffered secondary breaks from flying glass; and tube 4 had a passive ring-off in the inner absorber tube. The feeder tube is seen separated at the joint in tube 16 which fractured first. The rubber material used for this joint and tip protectors on the feeder tubes had been observed to soften and become putty-like after being subjected to temperatures of a second day boilout. It is not known if this separation resulted from the violent fracture, or caused the fracture by allowing the feeder tube to touch residual water which could then percolate up the tube to splash on the hot absorber tube. Pressure sensed at either side of the failed tube 16 is shown in Figure 18 and indicates no pressure surge before failure. Similarly, the temperature histories (Figs. 19, 20, and 21) for the failed tube and tubes either side of the failure indicate a stable condition at the time of failure.

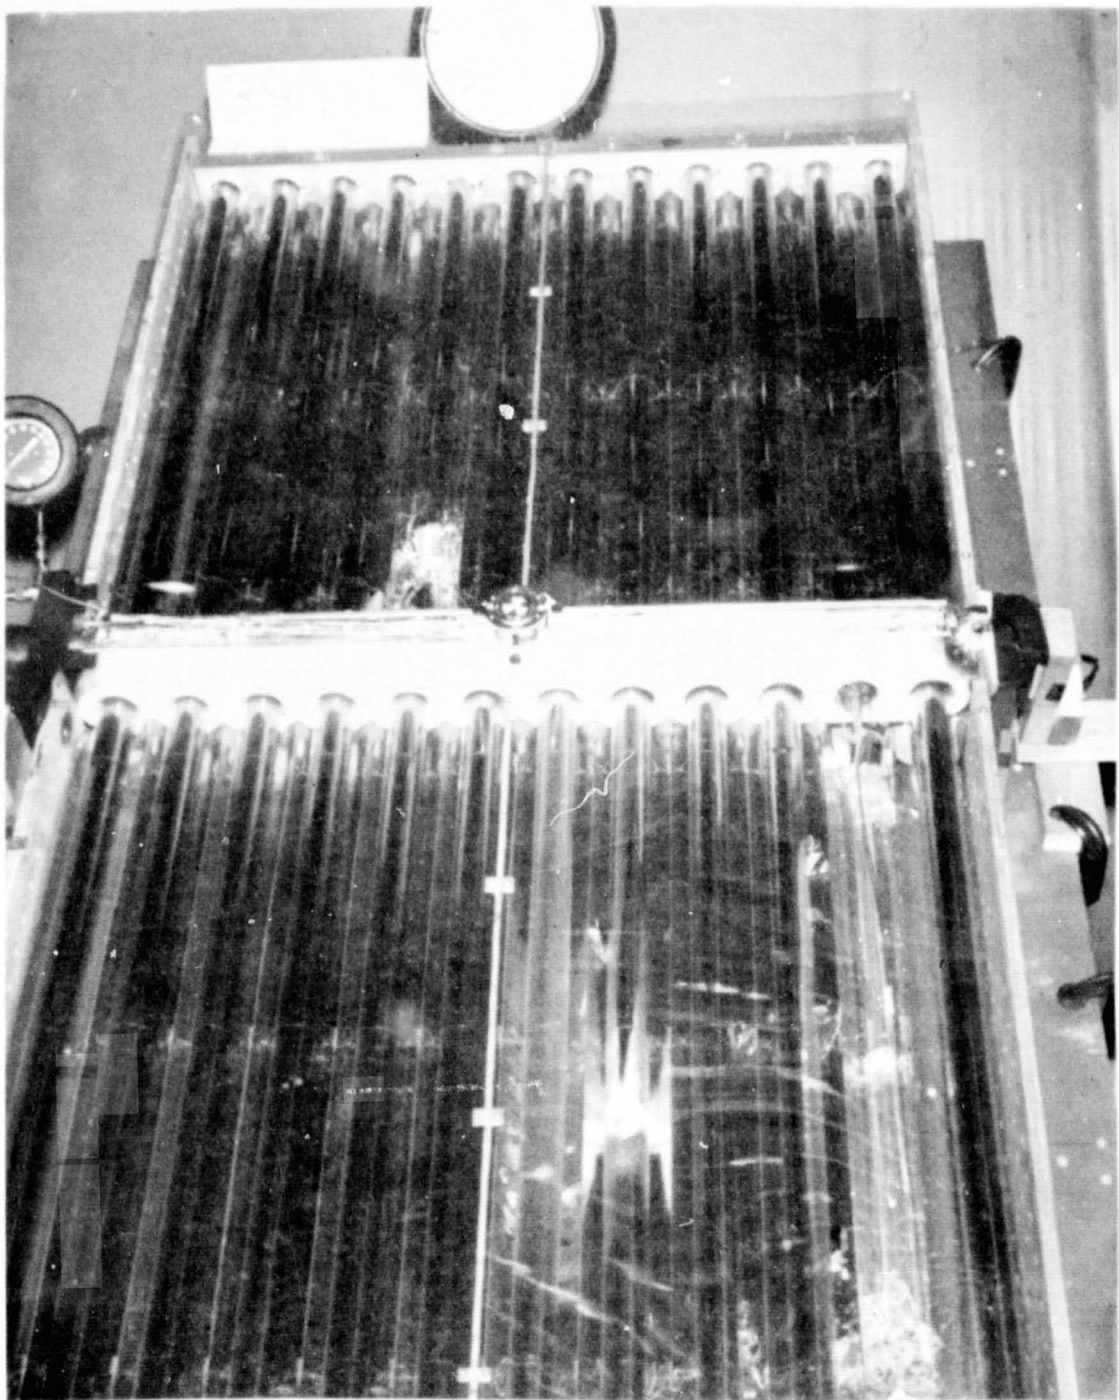
Figure 22. Second failure with scratched tubes.

Figure 22 shows the failed condition of the second set of scratched tubes. Tubes 5 and 23 experienced violent fracture as shown in Figures 23 and 24, respectively. It is noted that the feeder tube connection remained intact even though tube 23 suffered violent fracture. Passive ring-off breaks in absorber tubes 12, 19, 20, and 22 also occurred during failure of the second set of scratched tubes, as seen in Figure 25, by the condensation inside the affected tubes.

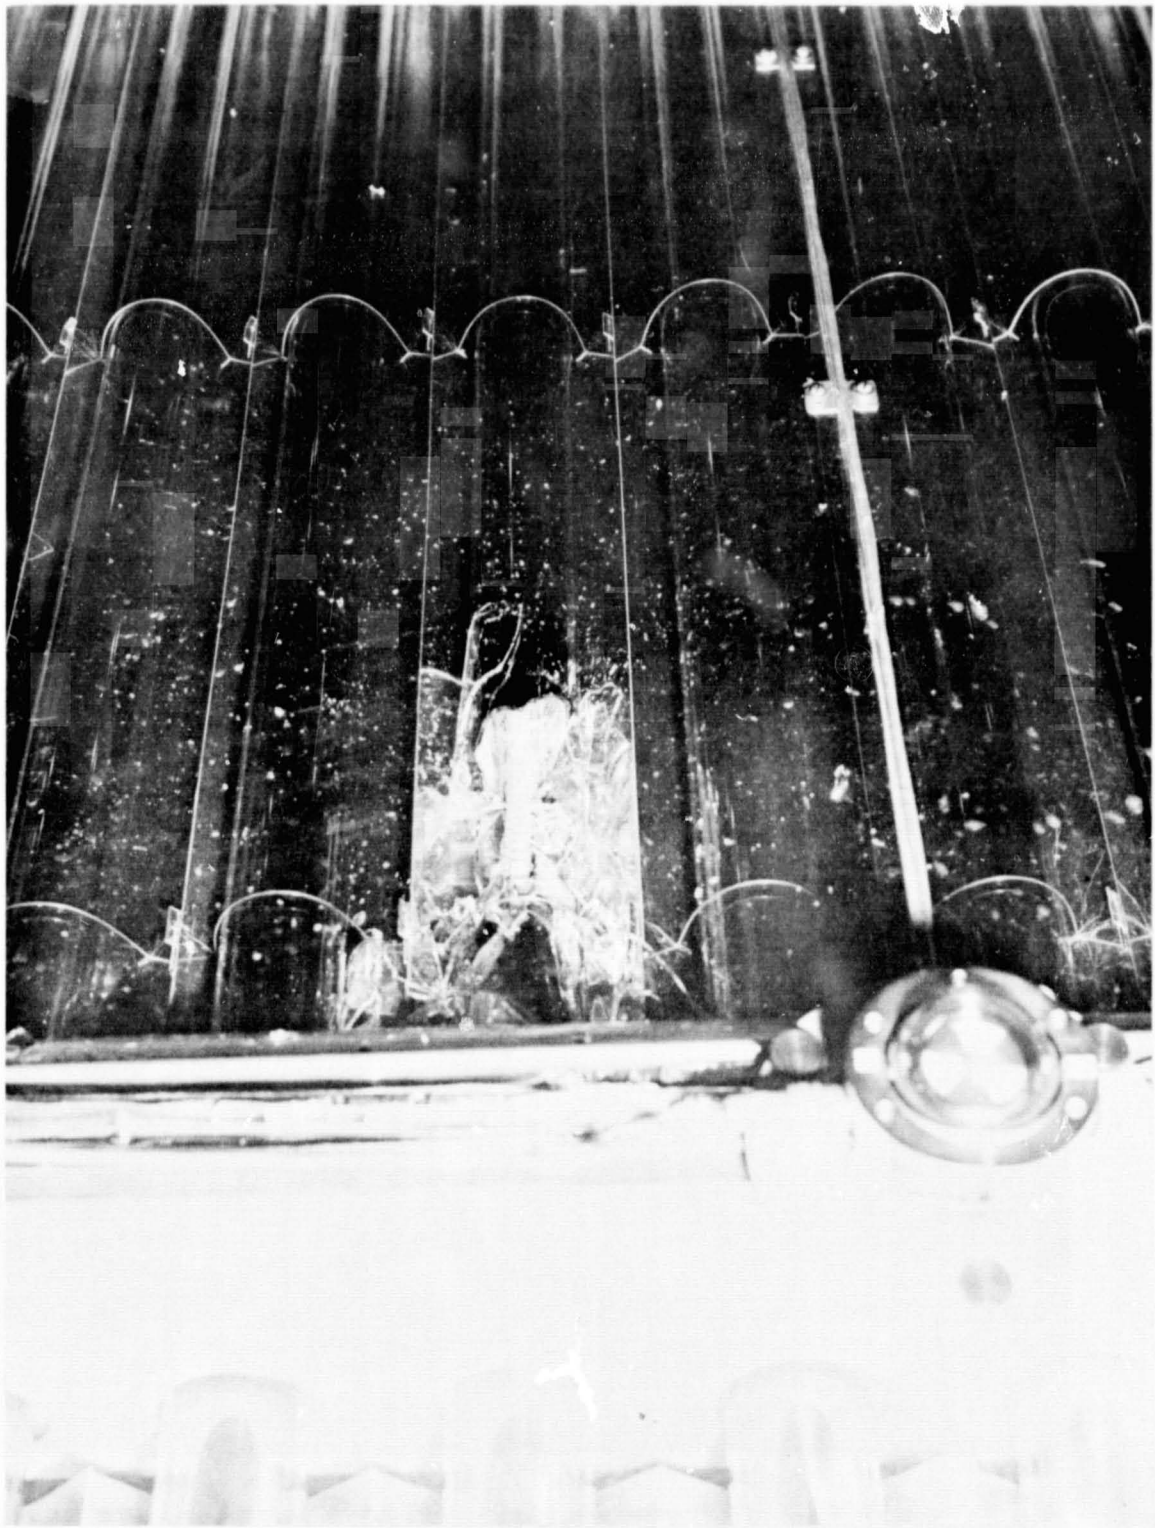
Figure 23. Tube 5 after violent fracture.

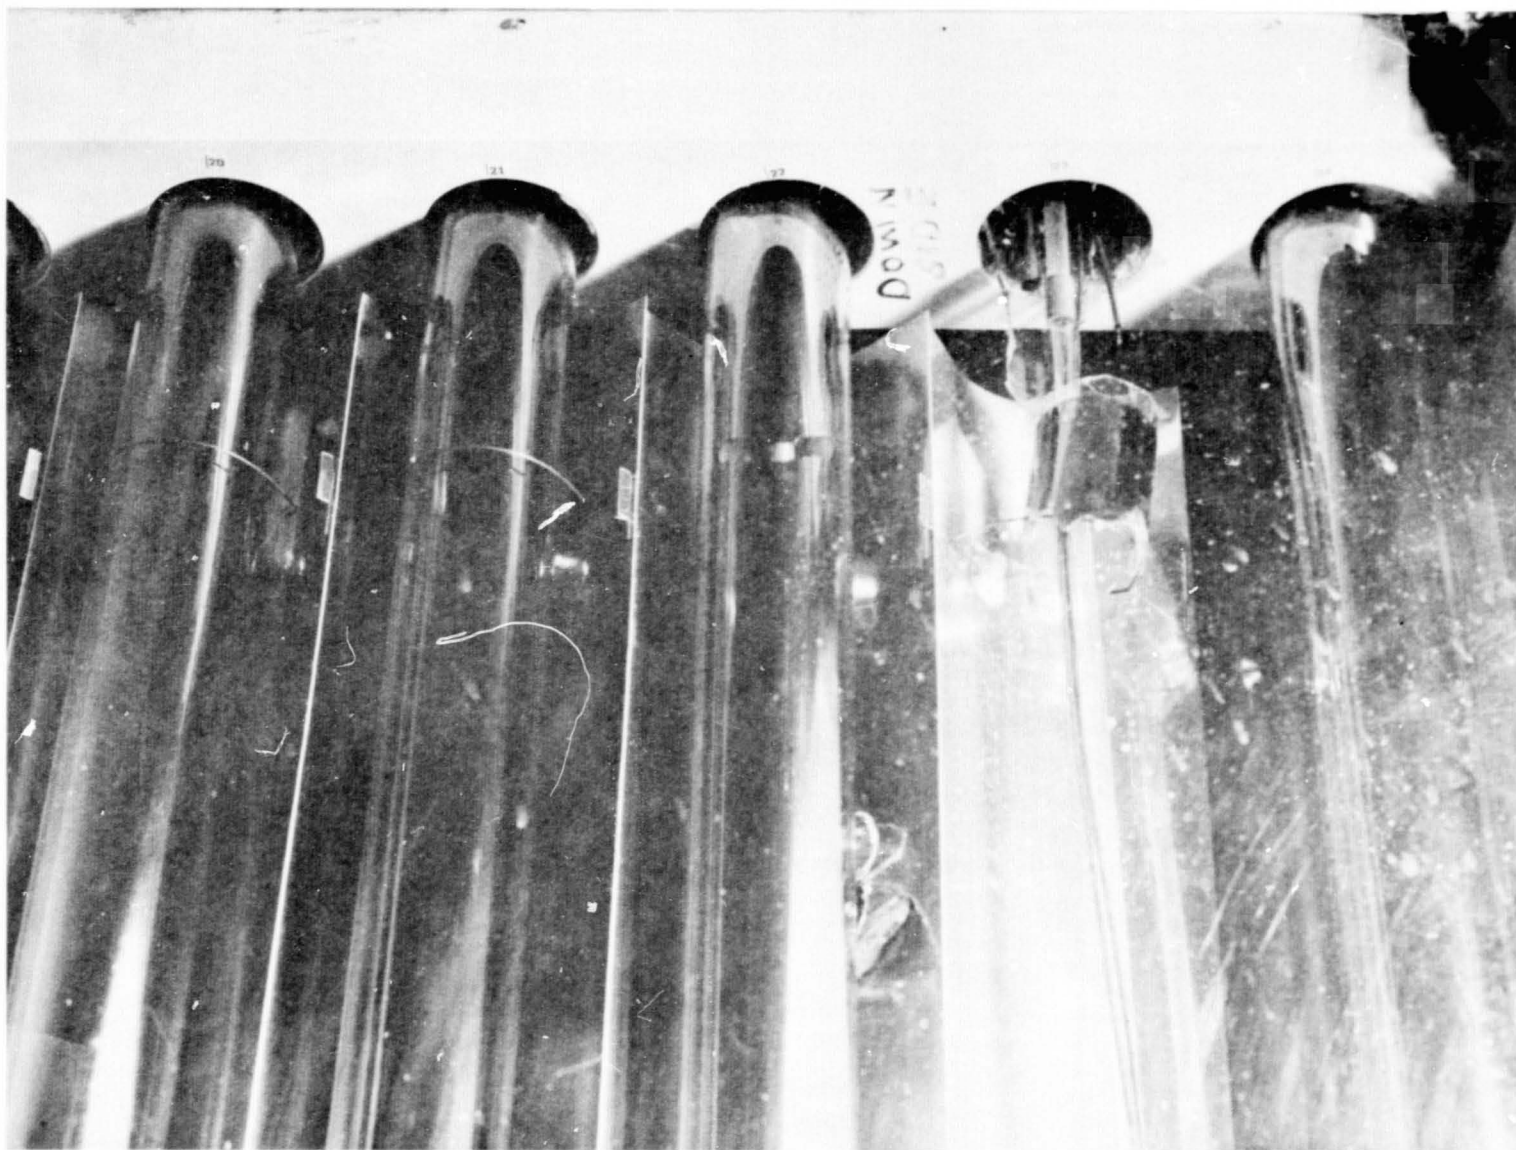
Figure 24. Tube 23 after violent fracture.

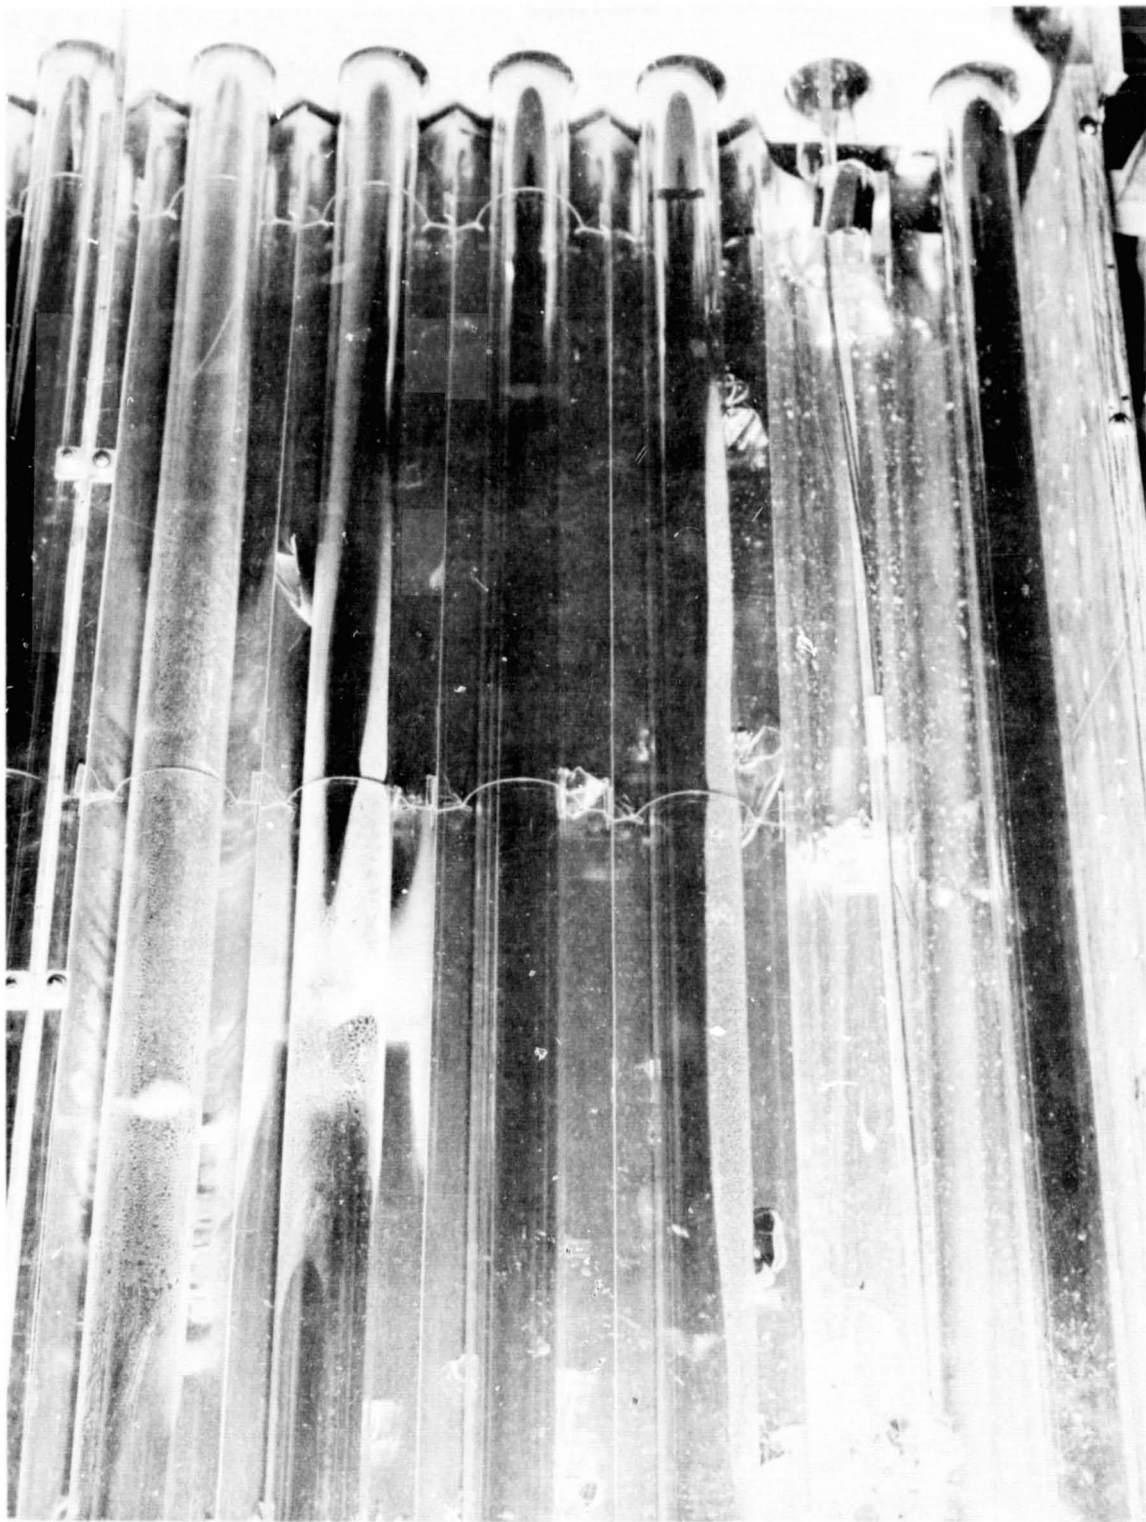
Figure 25. Ring-off breaks in absorber tubes.

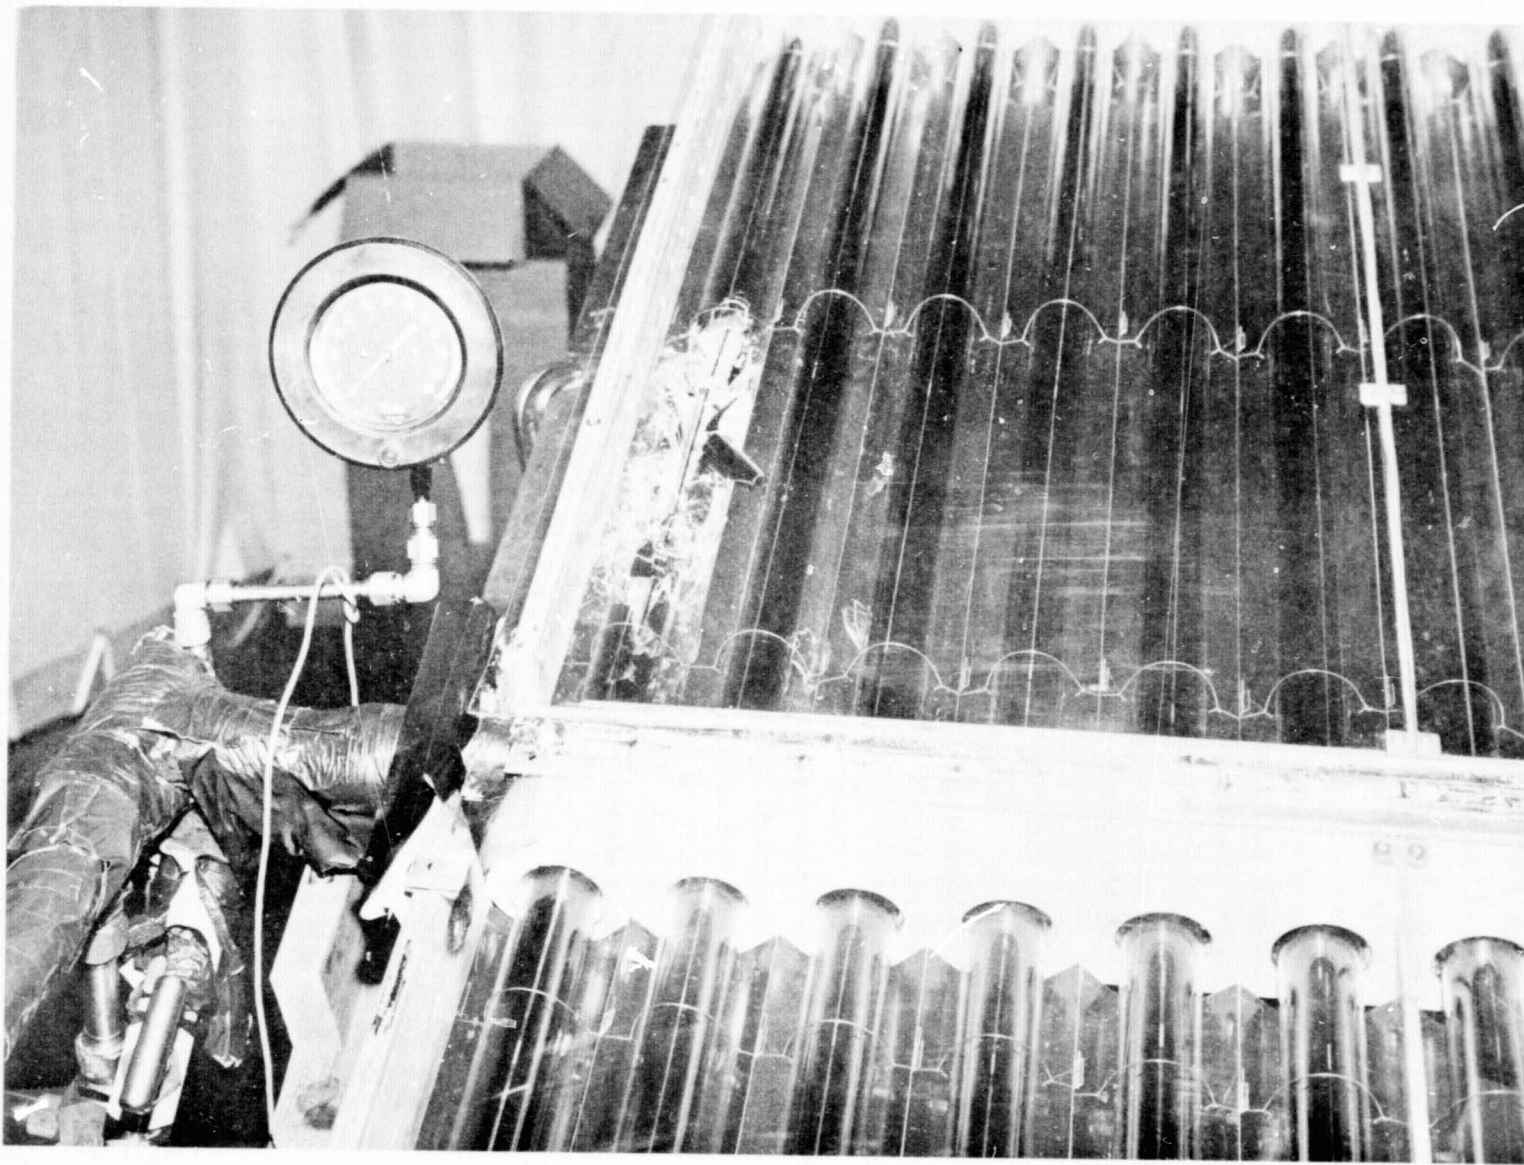
One final test was accomplished to simulate a "hot fill" condition. The collector was fitted with a good set of slotted tubes and illuminated by the solar simulator until stagnation temperature was reached. The tubes were dry and the collector outlet open to atmosphere pressure only. Then slow filling of the collector with warm tap water was begun. Tube 1 broke after being filled to approximately 40 percent capacity (Fig. 26). The collector was not pressurized during this test; therefore, the glass dispersion was less than when violent fracture occurred during the scratched tube boilout tests.

Figure 26. Hot-fill tube failure.

- a) No hot filling
- b) Design and install systems to avoid hot-fills, boilout and stagnation conditions, and to provide freeze protection where required
- c) Leak test assembled arrays at 55 psig or two times relief valve setting, if higher.

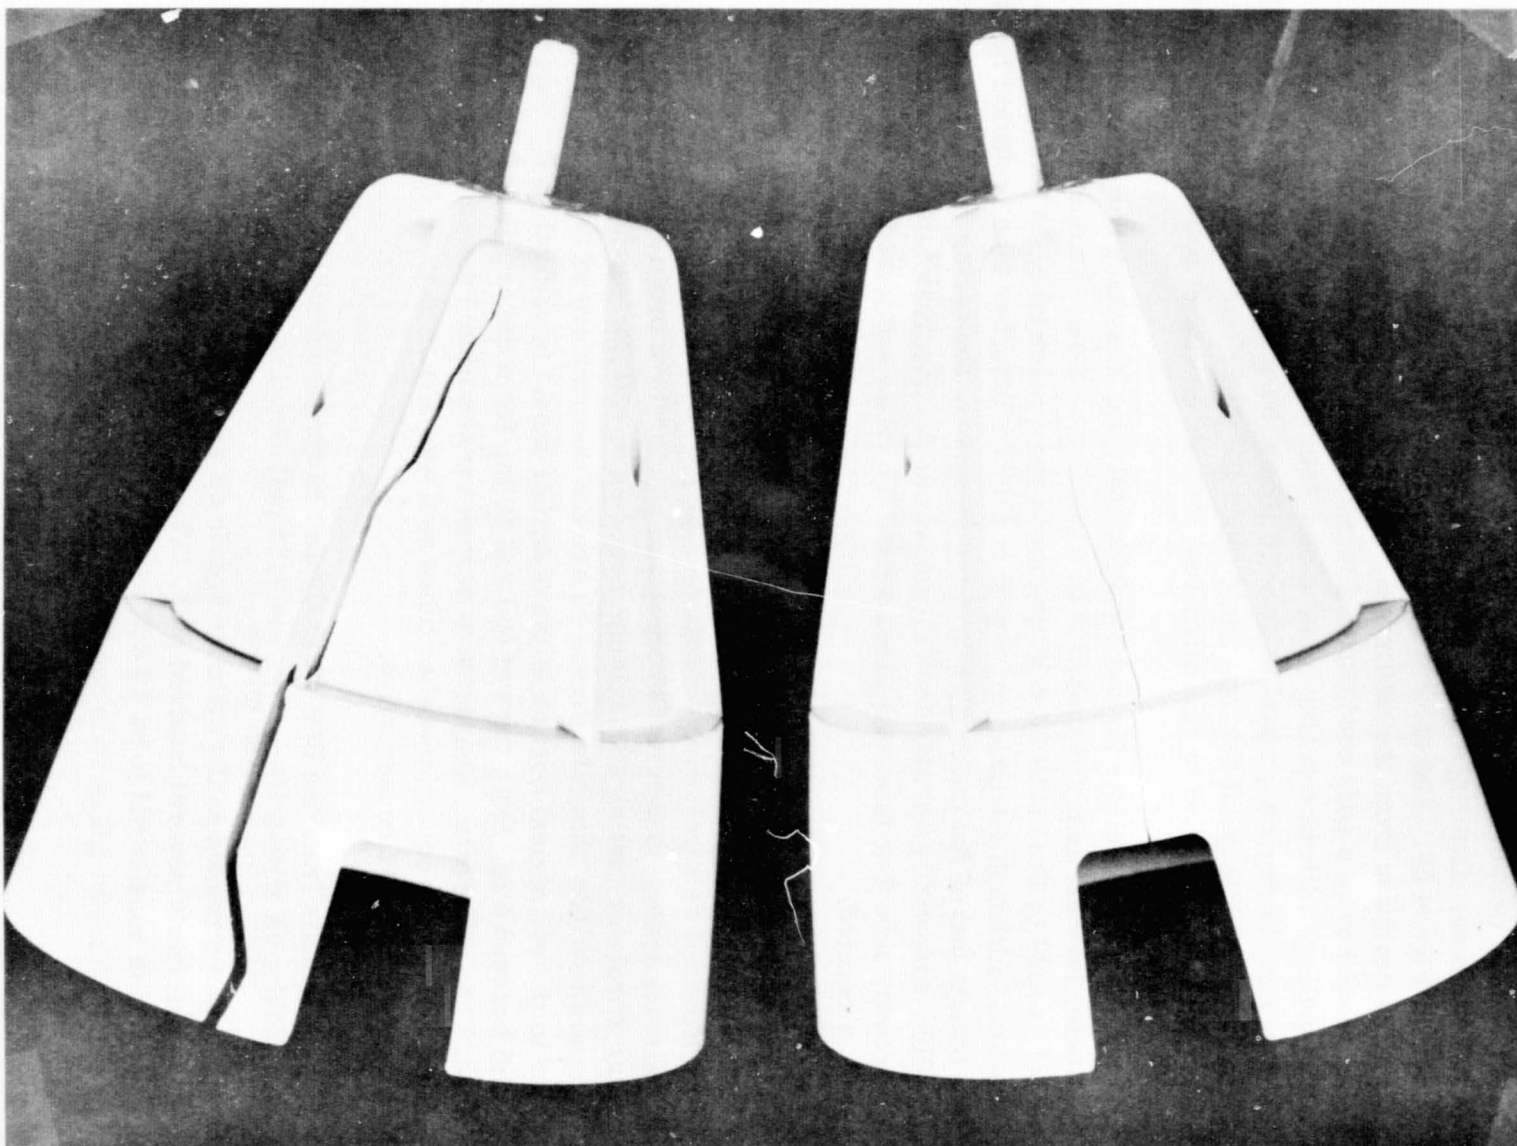
Figure 27. Tube support cup insert failure.

The only plastic component identified as a potential problem area is the tube support cup insert shown in Figure 27. Higher temperature materials are identified to overcome the thermal softening which caused leaks experienced during the boilout tests. Also, the contact surface should be increased to a conical shape to improve distribution of the load transferred to it from the dome end of the collector tube.
